*IPC Working Party on Harvesting and Utilization of Poplar and Willow Wood  
2<sup>nd</sup> Conference on Engineered Wood Products based on Poplar/Willow Wood  
León, Spain, September 8<sup>th</sup>- 10<sup>th</sup>*

## **Durability of exterior wood works in poplar from France in real conditions of use.**

*David Lorenzo, Magdalena Kutnik, Juan Fernández-Golfin, Manuel Touza, Manuel Guaita*

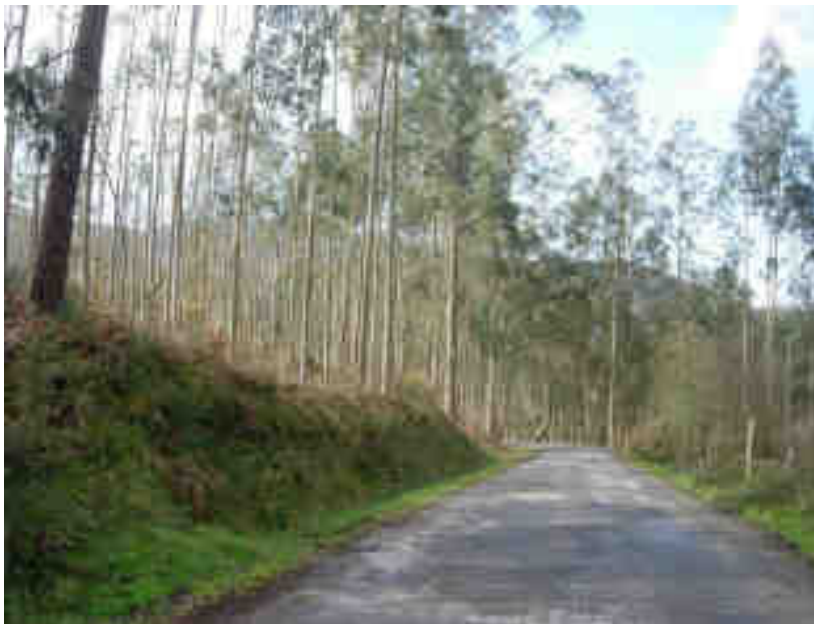
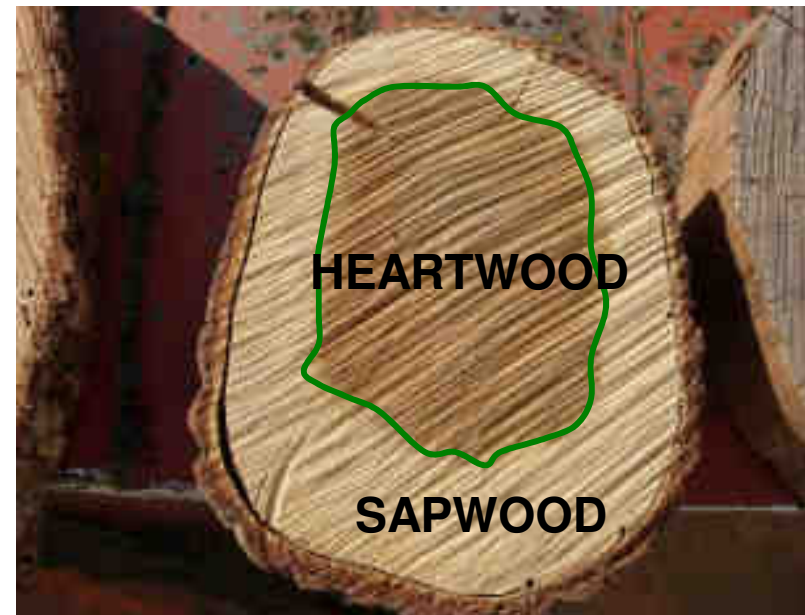
- **Natural durability** of wood depends on: **wood species**, **geographical origin**, **age**, **growth conditions** and the presence of **heartwood** or **sapwood**.

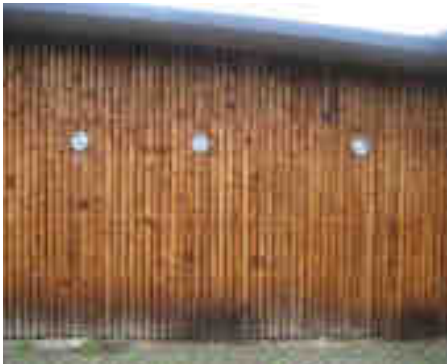
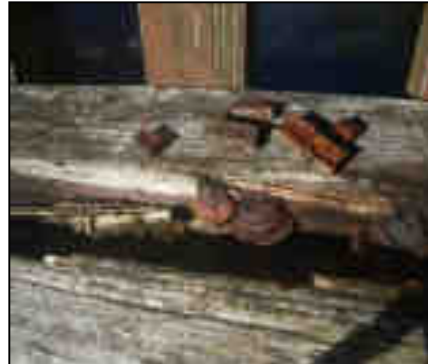
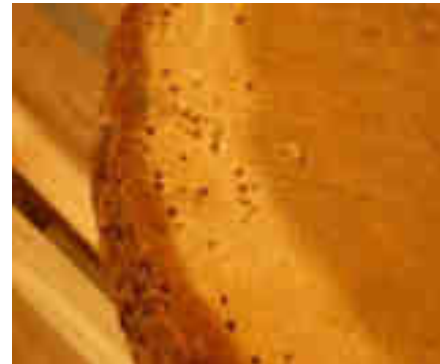
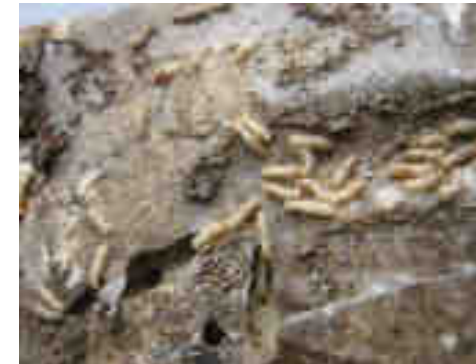
Main biological agents

- The main **biological agents** that may damage wood in exterior conditions above ground **Use Class 3** (European standard EN 335) are:
  - **Moulds and stains:** Cause aesthetically damage.
  - **Decay fungi:** Brown rot, white rot and soft rot fungi, which cause severe mass and strength losses to wood.
  - **Wood boring insects and termites:** cause significant damage.

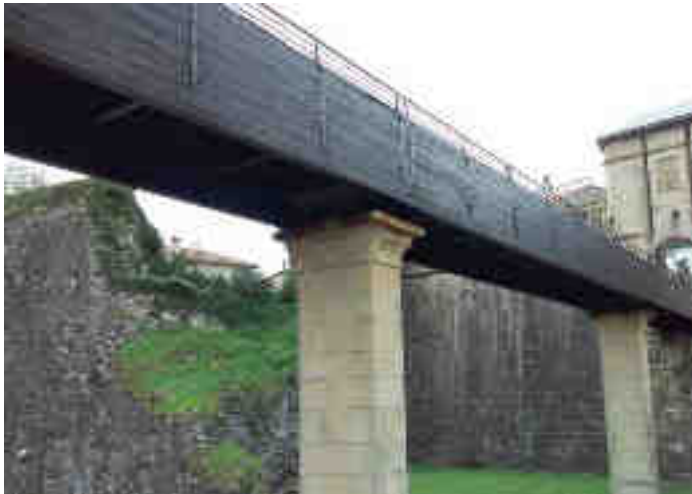
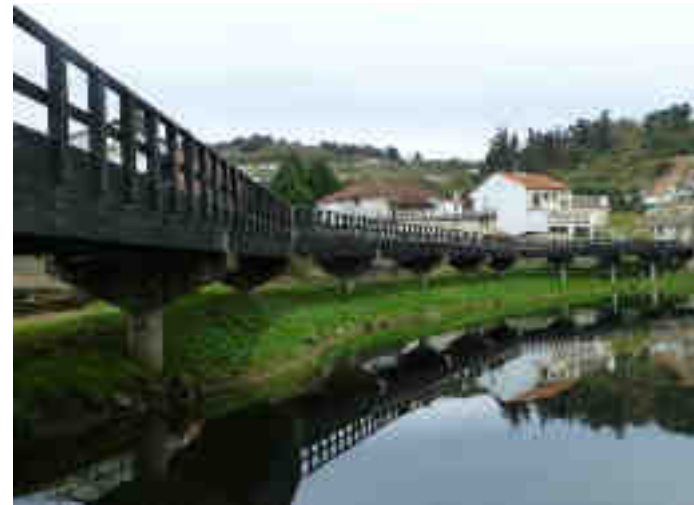
Exterior structures in Spain

- **Service life** of **exterior wood** (How long a wood product is expected to **perform**) depends on many factors: **material's inherent characteristics** and **environmental factors**.
- **Exposing wood** to **exterior conditions** (rain, sun, wind,...) highly increases the risks of the material being damaged by biological organisms such as **wood-destroying fungi** and **wood-boring insects**.
- Proper **design** and **protection** of wood products for exterior uses are crucial to ensure the best **service life** for them.

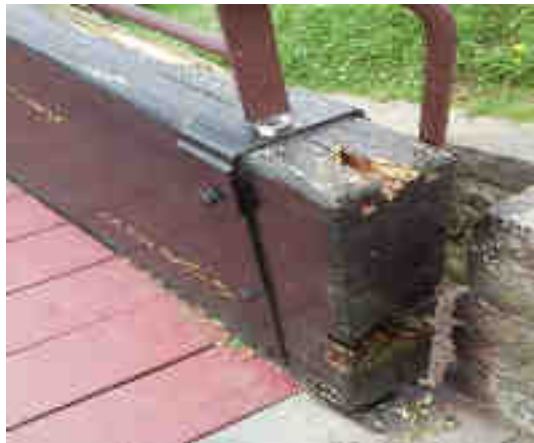
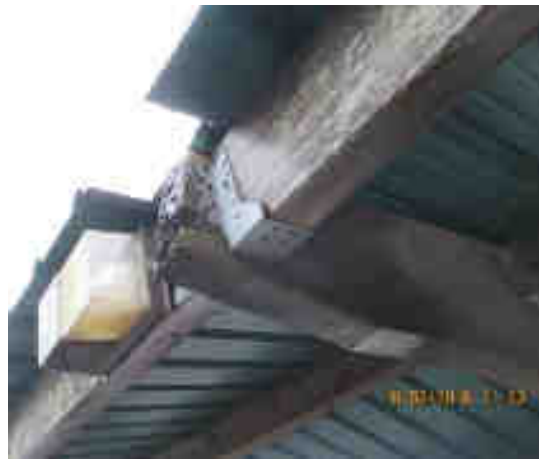
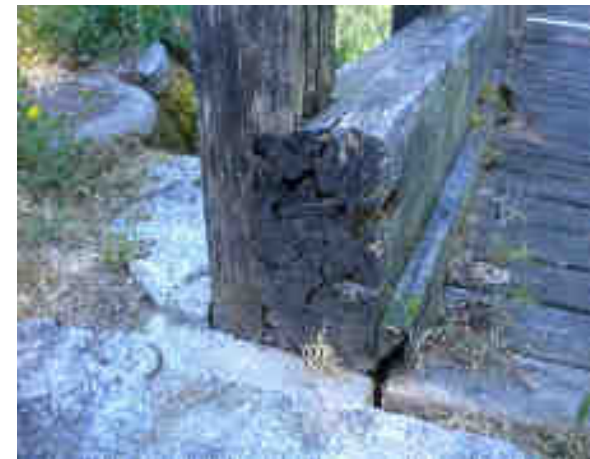
- Bad practices in the **design exterior wood commodities** often result excessive **moisture content** in the wood. Wood products can contain **zones** where **rainwater** may **accumulate**, which are generally places where **fungal attacks** occur.
- **Mistakes** made in the **design** often lead that a **wood element** initially meant for **Use Class 3** are finally exposed to a level of **biological risk** that is **higher** than expected in this Use Class 3.
- As a result, in situations where **exterior wood components** are not in ground contact may **permanently accumulate water** due to their design.

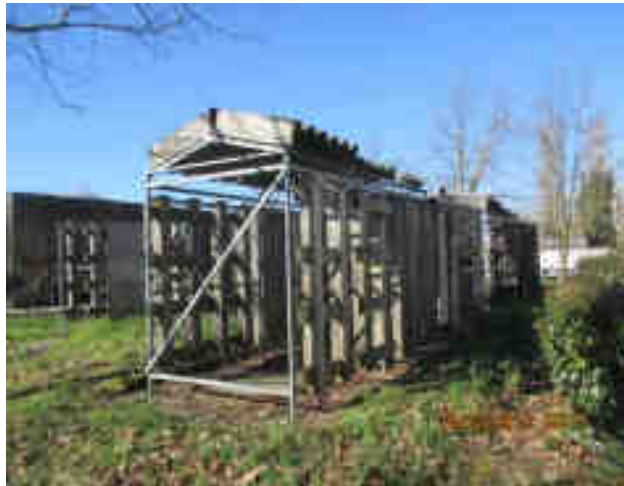
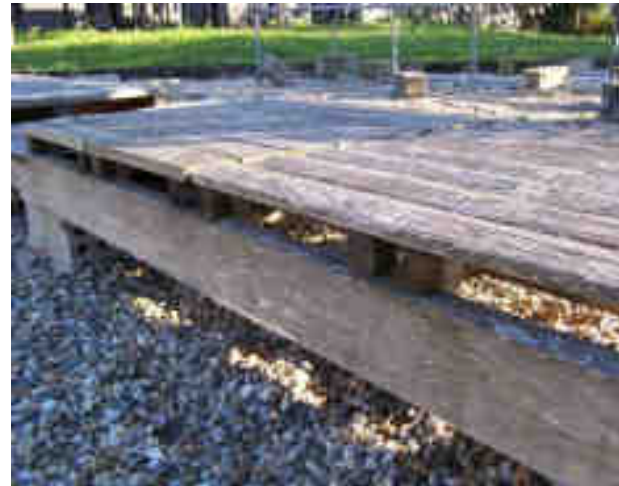
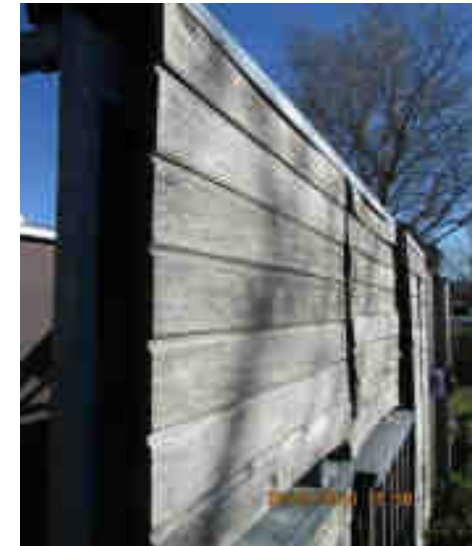
Experimental Set up in Bordeaux, France

- The **current test** used to evaluate the **natural durability** of wood species don't very well correspond with the ways of evaluating **durability, performance** and **service life** of wood exterior commodities.
- The aim of the **experimental test** is to work out a protocol which will make it possible to estimate **durability, performance** and **service life**, in real situations of different **9 wood species** from **France** (in this case focusing in **poplar**).
- This will involve quantifying the impact of **material, climate, exposure, and design** of selected **exterior wood components** of **poplar**.

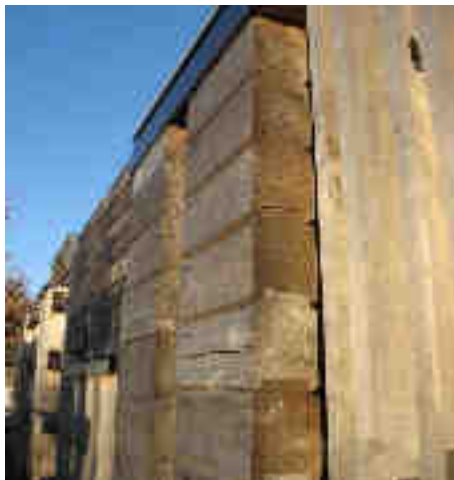
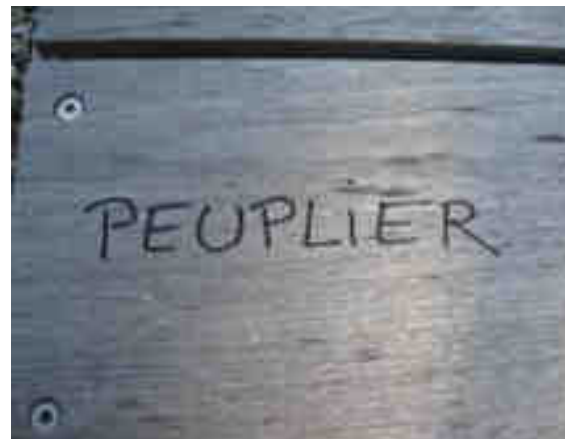
Poplar from France

- **Poplar** (*Populus* sp.) is a wood species which is of economic importance for the construction industry in **France**.
- It was also chose because it's a **non-durable fungal decay** (Durability class 5 according to the European Standard EN 350) and subject to attacks by **insects**.

- Including a **non-durable species** as **Poplar** in the test will allow evaluating the impact of design on fungal decay's kinetics after a short period of time (<10 years).
- It should be noted that in reality **poplar** for **exterior applications** is rarely used **without any preservative treatment**.

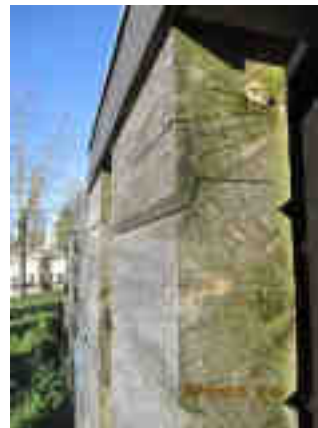
### Current commercial

- 2 different designs were chosen. The main differences are the **shape** of the logs and their **ability to facilitate water drainage**. Identical sets of log walls were installed in situations that either allow or prevent their direct exposure to driven rain.
- Two different walls 2 meters high and 50 cm wide were made with **poplar**.

Water penetration  
by capillarity

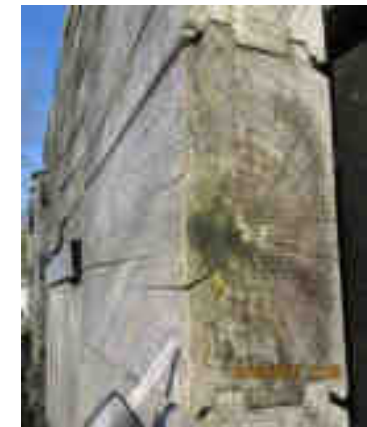
### Improved design

Water deflection

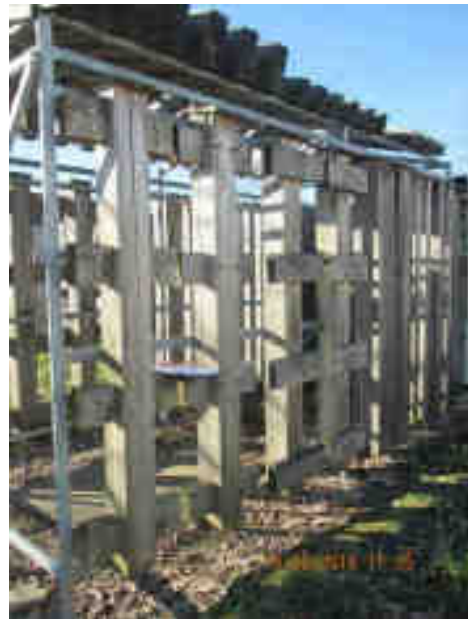
### Current commercial design

- Different kinds of joinery are being tested which are representative of traditional carpentry.
- 2 innovative types of joint are also being tested (use of stainless steel connectors) which reduce the wood-to-wood contact zones and allow for efficient water drainage from the two connected elements.
- Their end-grain was protected from rainwater by stainless steel sheets.

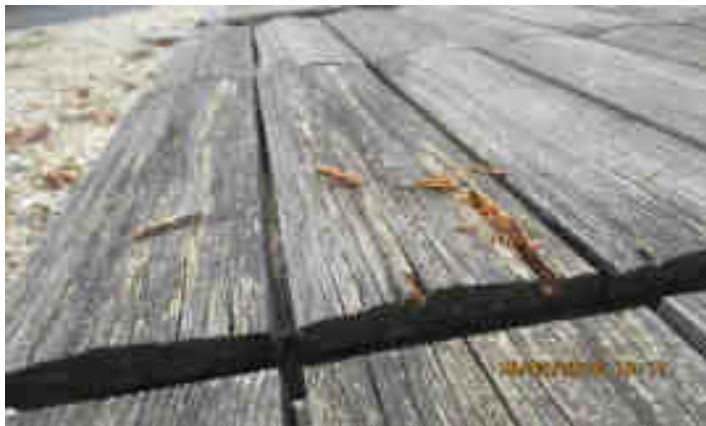
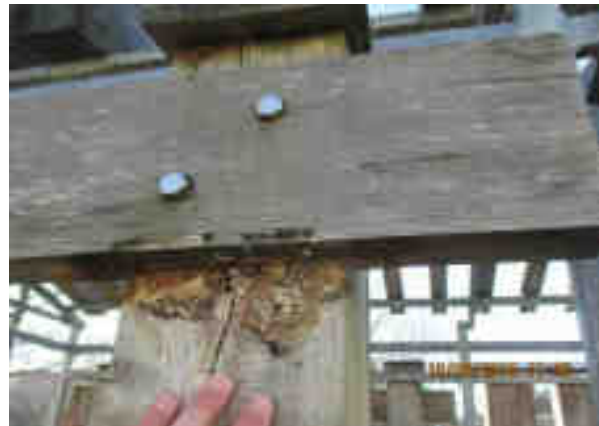
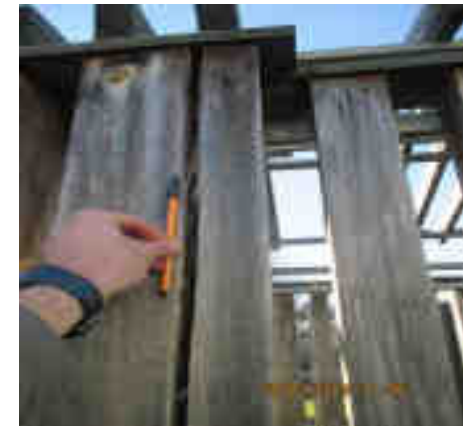
- The progress of moulds, blue stain, fungal decay, insects as well as cracks, shrinks, swelling and mechanical defects is monitored **once a year**, starting in **2010**.
- Due differences among exposure **sites** and different **designs** the experiment will be conducted over a period of **ten years (2020)**.
- The study is focus in **Poplar, Bordeaux site** and **six years of exposure (2016)**
- The **poplar test specimens** are evaluated by rating the extent and distribution of **decay** according to **EN 252 (1989)** as: **0** (sound), **1** (slight attack), **2** (moderate attack), **3** (severe attack) or **4** (failure).
- The **mechanical behaviour** and **physical degradation** of the exposed wood (cracks, swelling, shrinking, wooden movements) were evaluated visually.

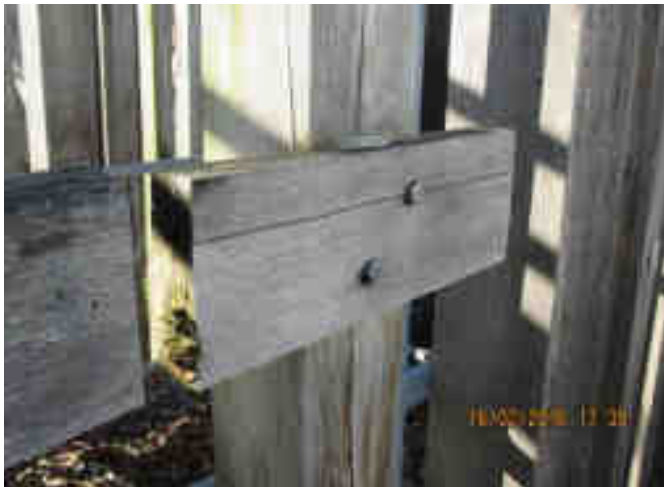
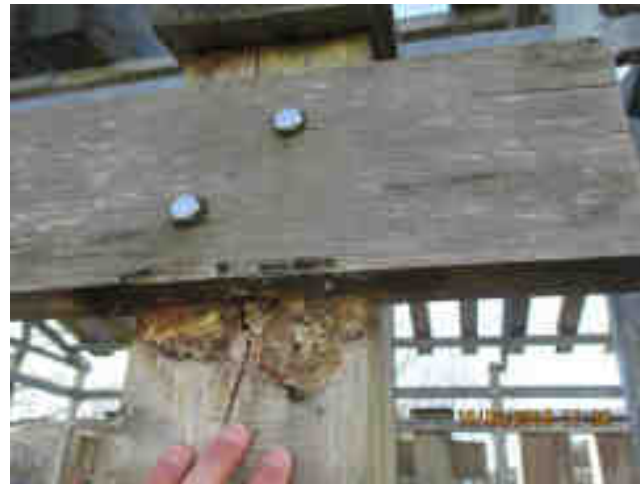
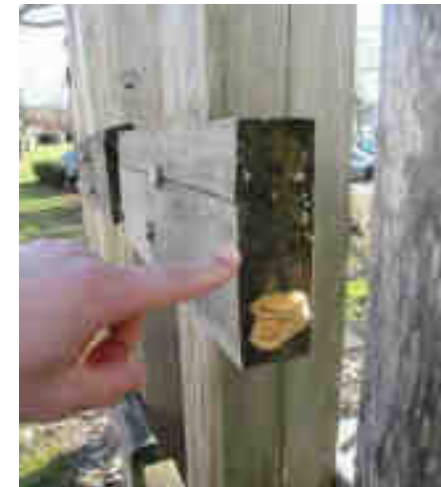
- In the **set of commodities No. 1**, all **poplar test specimens** were rated a minimum of **1** (slight attack) for decay. The most common is **rating 2** (moderate attack), in some cases **rating 3** (severe attack) and depending of design even is possible to find in some test specimens in the **severe exposure rating 4** (failure)
- Regard to the **mechanical behaviour**, in the set of commodities No. 1 **big differences** were reported with poplar test specimens exposed to **severe exposure** (South-West) where cracking, UV aging, swelling and shrinking strongly affecting the wooden poplar elements in comparison with low exposure facade (North-East).

- In the **set of commodities No. 1**, **significant differences** in terms of **durability**, and **mechanical behaviour** were reported in poplar test specimens exposed to **severe exposure** in comparison with low exposure (with better results) and also depending on different designs.
- In the case of **deckings**, **significant differences** in terms of **durability** were found between the different **designs** but not in **mechanical behaviour**.
- The research project presented here contributes to the knowledge of how to extend the **durability**, **performance** and **service life** of commodities made with untreated **poplar** and increase the value of poplar wood.
- However, after only **six year of exposure**, the results need to be considered as preliminary.
